**Flood Control Project Maintenance  
Levee Inspections**

## Maintenance Issue Types Only, Levee Inspection Report By Mile - Spring 2018

### Reclamation District No. 2031 Elliot

Waterway	Bank	Unit Miles	Inspection Start/End	Inspector
Unit No. 01 Stanislaus River	Left	7.07	05/16/2018 05/16/2018	Sterling York

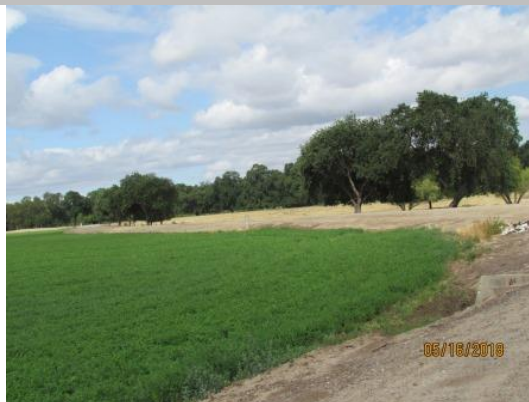
Photo 1 of 1 : SP\_2018\_RD2031\_307\_34\_20180517\_00105.jpg

LM Start	0.03	Rating **	A	Issue No.	34
LM End	7.07	Issue Type +	Ma	Location *	LS
Category	Earthen Levee		GPS Latitude/Longitude		
			Start	End	
Item	Vegetation		37.709990°	37.661853°	
			-121.155869°	-121.232863°	
DWR ID	DWR_RD2031_01_s_2018_34				
Comment Code					
V1 : Control annual grass and weeds on the levee slopes and easements.					
Inspector Comment

View looking downstream landside of the well maintained annual vegetation.

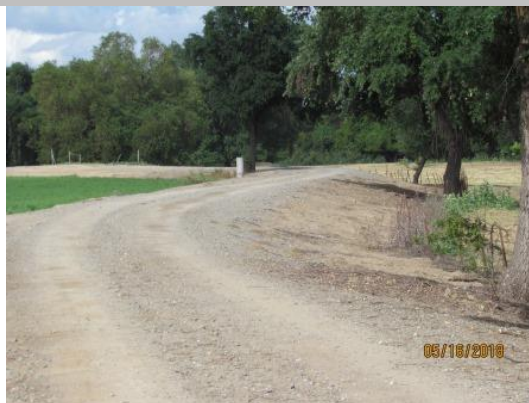
Photo 1 of 1 : SP\_2018\_RD2031\_307\_38\_20180517\_00106.jpg

View looking downstream waterside of the well maintained annual vegetation.

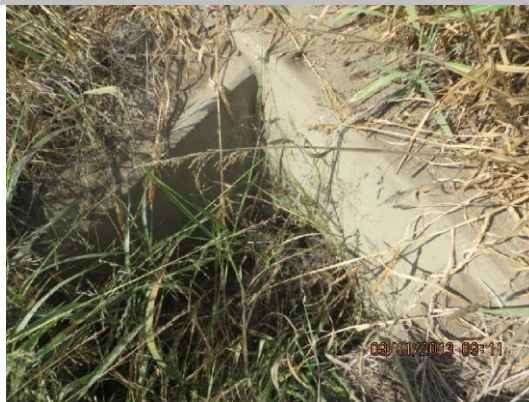
Photo 1 of 2 : UCIP\_SP\_2018\_20024\_33924.jpg

LM Start	0.35	Rating **	A/W	Issue No.	983
LM End	0.35	Issue Type +	Ma	Location *	
Category	Supplemental			GPS Latitude/Longitude	
				Start	End
Item	DWR UCIP LMA Responsibility			37.705932 °	37.705932 °
				-121.157985 °	-121.157985 °
DWR ID					
Comment Code					
Inspector Comment					
FS_ID:20024					
DS_ID:20437					
EP_NO: N/A					
Repair Type: No Action Needed					
Crossing Status: Found					
UCIP Comments:					
FIELD_STRUCT_DESC: 24-inch corrugated metal drainage pipe					
through the levee, 3.5 feet below the crown. Concrete U-shaped					
headwalls on both ends. Flap gate on the waterside (WS) end. Installed					
by USACE in 1966. [Additional Reference(s): DWR Levee Log, 2005.					
USACE San Joaquin O&M Manual 4, June 1968, (HLM 0.36)].					
FS Date: 9/11/2013

Concrete headwall on LS slope.

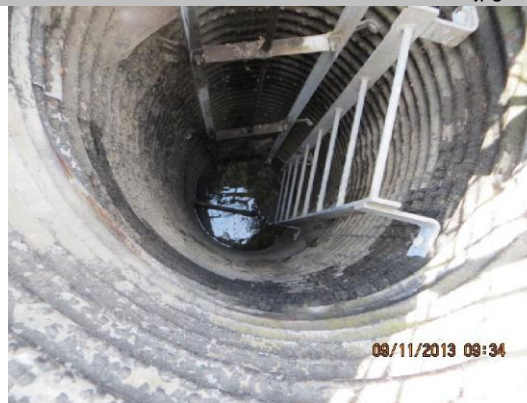
Photo 2 of 3 : UCIP\_SP\_2018\_20044\_33941.jpg

FS\_ID:20044  
DS\_ID:20439  
EP\_NO: N/A  
Repair Type: No Action Needed  
Crossing Status: Found  
UCIP Comments:  
FIELD\_STRUCT\_DESC: 15-inch corrugated metal drainage pipe through the levee, 9 feet below the crown. Slide gate in a 36-inch corrugated metal pipe (CMP) riser on the waterside (WS) slope. Drainage canal off the landside (LS) toe. This pipe replaced a 15-inch pipe at the same location. [Additional Reference(s): DWR Levee Log, 2005. USACE San Joaquin O&M Manual 4, June 1968, (HLM 0.57)].  
FS Date: 9/11/2013

Slide gate in CMP riser on WS shoulder.

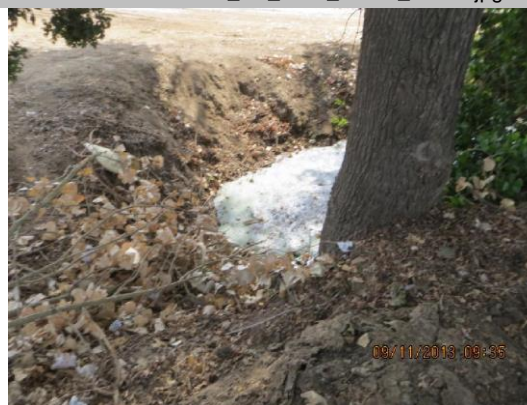
Photo 3 of 3 : UCIP\_SP\_2018\_20044\_33940.jpg

Drainage ditch at inlet on LS toe.

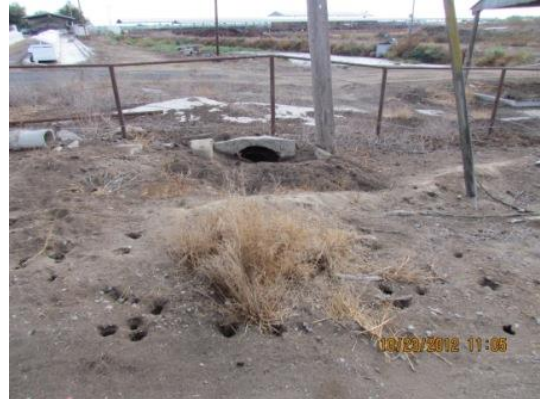
Photo 1 of 1 : SP\_2018\_RD2031\_307\_36\_20180515\_00019.jpg

View of rodent burrows on landside slope.

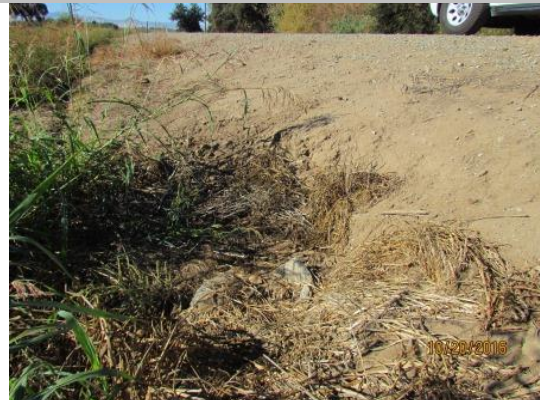
Photo 1 of 1 : SP\_2018\_RD2031\_307\_42\_20180515\_00023.jpg

View of the erosion of the landside levee slope.

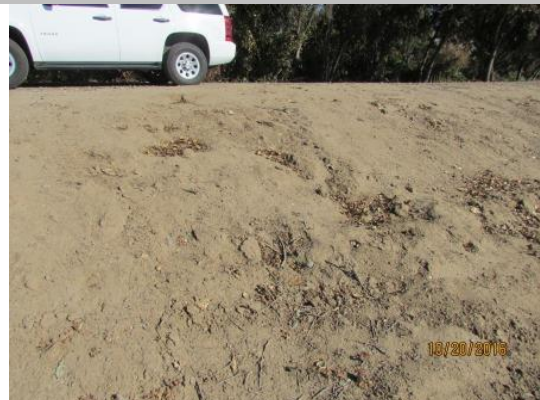
Photo 1 of 3 : SP\_2018\_RD2031\_307\_59\_20180515\_00036.jpg

View of the rodent holes on the landside levee slope.

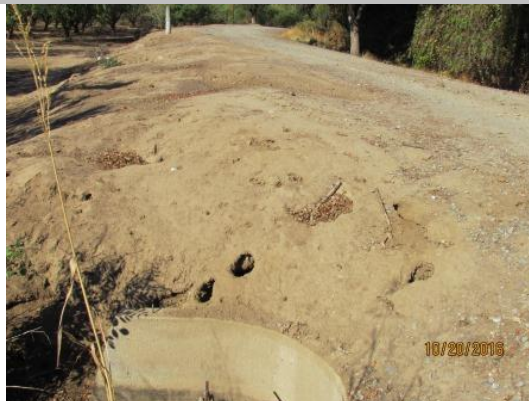
Photo 2 of 2 : SP\_2018\_RD2031\_307\_44\_20180515\_00026.jpg

Another view of the rodent holes on the landside levee slope.

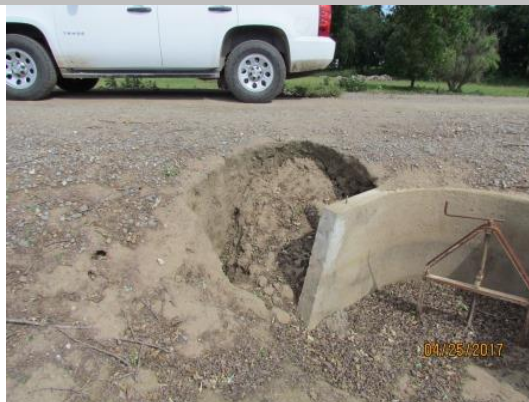
Photo 1 of 1 : SP\_2018\_RD2031\_307\_62\_20180515\_00039.jpg

LM Start	1.41	Rating **	U	Issue No.	62
LM End	1.41	Issue Type +	Ma	Location *	LS
Category	Earthen Levee			GPS Latitude/Longitude	
				Start	End
Item	Erosion / Bank Caving			37.699833 °	37.699833 °
				-121.172060 °	-121.172060 °
DWR ID	DWR_RD2031_01_s_2017_62				
Comment Code					
E2 : Schedule repair of erosion site prior to the next inspection.					
Inspector Comment

View of the erosion on the levee slope penetrating levee prism.

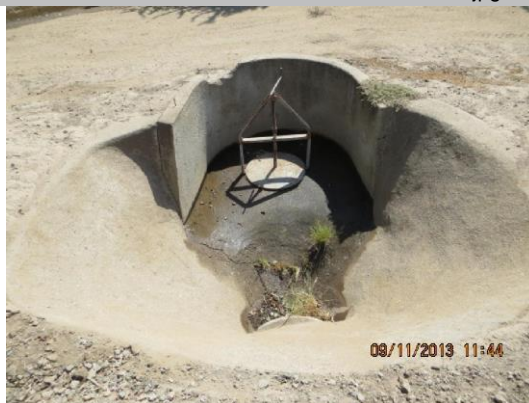
Photo 1 of 3 : UCIP\_SP\_2018\_20088\_34030.jpg

LM Start	1.55	Rating **	A/W	Issue No.	990
LM End	1.55	Issue Type +	Ma	Location *	
Category	Supplemental			GPS Latitude/Longitude	
				Start	End
Item	DWR UCIP LMA Responsibility			37.698921 °	37.698921 °
				-121.174144 °	-121.174144 °
DWR ID					
Comment Code					
Inspector Comment					
FS_ID:20088 DS_ID:20446 EP_NO: N/A Repair Type: No Action Needed Crossing Status: Found UCIP Comments: FIELD_STRUCT_DESC: 24-inch corrugated metal drainage pipe through the levee, 3.5 feet below the crown. Concrete headwalls on both ends. Flap gate on the waterside (WS) end. Installed by USACE in 1966. [Additional Reference(s): DWR Levee Log, 2005. USACE San Joaquin O&M Manual 4, June 1968, (HLM 1.56)]. FS Date: 9/11/2013

Bowl shaped concrete inlet on LS slope.

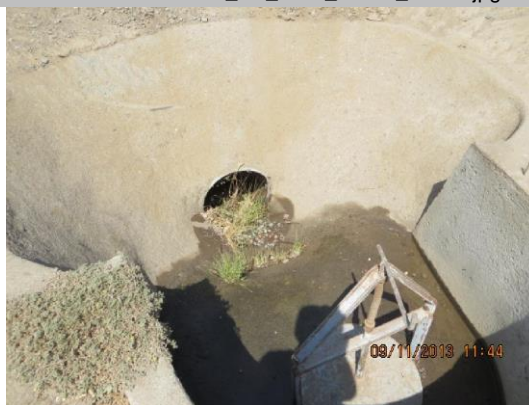
Photo 2 of 3 : UCIP\_SP\_2018\_20088\_34029.jpg

Bowl shaped concrete inlet on LS slope.

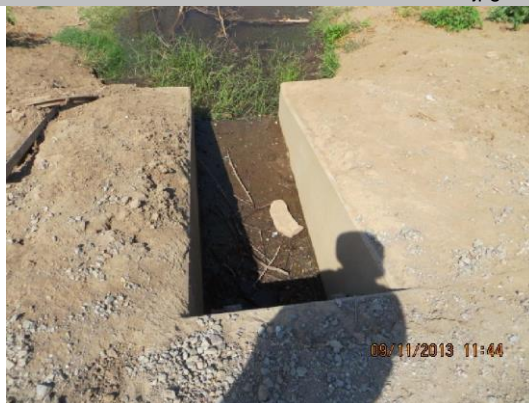
Photo 3 of 3 : UCIP\_SP\_2018\_20088\_34028.jpg

LM Start	1.55	Rating **	A/W	Issue No.	990 (cont)	
LM End	1.55	Issue Type +	Ma	Location *		
Category	Supplemental			GPS Latitude/Longitude		
				Start	End	
Item	DWR UCIP LMA Responsibility			37.698921 °	37.698921 °	
				-121.174144 °	-121.174144 °	
DWR ID						
Comment Code						
Inspector Comment						
FS_ID:20088						
DS_ID:20446						
EP_NO: N/A						
Repair Type: No Action Needed						
Crossing Status: Found						
UCIP Comments:						
FIELD_STRUCT_DESC: 24-inch corrugated metal drainage pipe						
through the levee, 3.5 feet below the crown. Concrete headwalls on						
both ends. Flap gate on the waterside (WS) end. Installed by USACE in						
1966. [Additional Reference(s): DWR Levee Log, 2005. USACE San						
Joaquin O&M Manual 4, June 1968, (HLM 1.56)].						
FS Date: 9/11/2013

Concrete U-shaped headwall on WS slope.

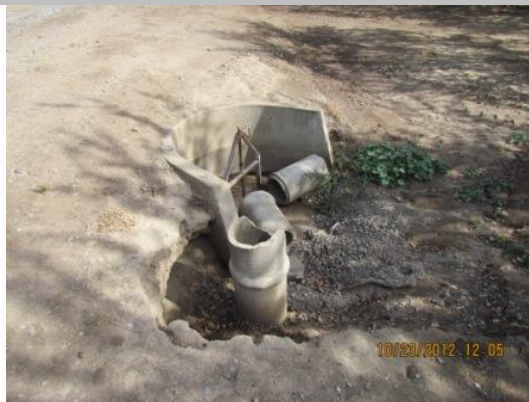
Photo 1 of 2 : SP\_2018\_RD2031\_307\_3\_20180515\_00001.jpg

LM Start	1.56	Rating **	U	Issue No.	3
LM End	1.56	Issue Type +	Ma	Location *	LS
Category	Earthen Levee			GPS Latitude/Longitude	
				Start	End
Item	Erosion / Bank Caving			37.698776 °	37.698776 °
				-121.174327 °	-121.174327 °
DWR ID	DWR_RD2031_01_s_2012_3				
Comment Code					
E1 : Note and monitor erosion site.					
Inspector Comment					
Erosion is active around the irrigation standpipe.

View of the erosion site on landside slope, facing upstream.

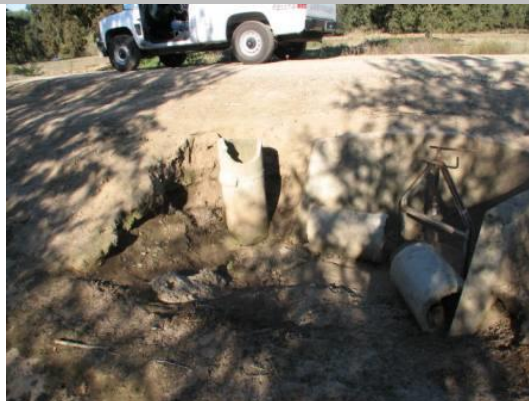
Photo 2 of 2 : SP\_2018\_RD2031\_307\_3\_20180515\_00002.jpg

10/26/2011 Active erosion into the levee prism around irrigation standpipe.

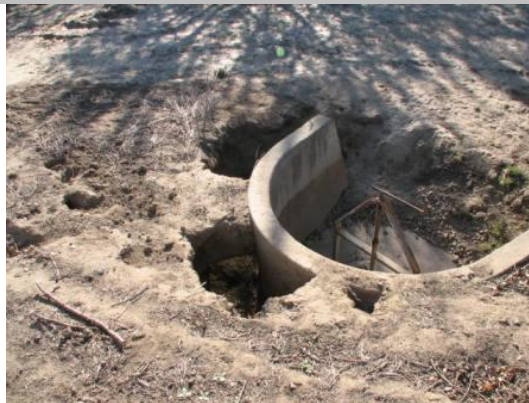
Photo 1 of 1 : SP\_2018\_RD2031\_307\_9\_20180515\_00008.jpg

LM Start	1.58	Rating **	U	Issue No.	8
LM End	1.58	Issue Type +	Ma	Location *	WS
Category	Earthen Levee			GPS Latitude/Longitude	
				Start	End
Item	Erosion / Bank Caving			37.698610 °	37.698610 °
				-121.174598 °	-121.174598 °
DWR ID	DWR_RD2031_01_s_2012_8				
Comment Code					
E1 : Note and monitor erosion site.					
Inspector Comment					
Active erosion is occurring around irrigation inlet.

10/26/2011 Active erosion into levee prism around irrigation inlet.

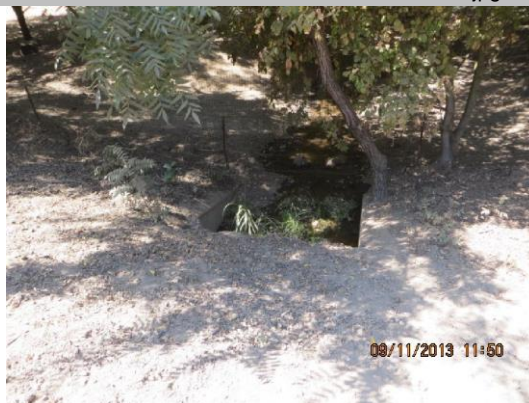
Photo 1 of 3 : UCIP\_SP\_2018\_41354\_34034.jpg

LM Start	1.78	Rating **	M	Issue No.	991
LM End	1.78	Issue Type +	Ma	Location *	
Category	Supplemental			GPS Latitude/Longitude	
				Start	End
Item	DWR UCIP LMA Responsibility			37.696958 °	37.696958 °
				-121.177464 °	-121.177464 °
DWR ID					
Comment Code					
Inspector Comment					
FS_ID:41354 DS_ID:20470 EP_NO: N/A Repair Type: Non-Urgent Crossing Status: Found UCIP Comments: Silt buildup at inlet and outlet. FIELD_STRUCT_DESC: 1 of 2: 24-inch corrugated metal drainage pipe through the levee, 9.5 feet below the crown. Concrete U-shaped headwalls on both ends. Flap gate on the waterside (WS) end. Installed by USACE in 1966. [Additional Reference(s): DWR Levee Log, 2005. USACE San Joaquin O&M Manual 4, June 1968, (HLM 1.80)]. FS Date: 9/11/2013

Concrete headwall on WS toe.

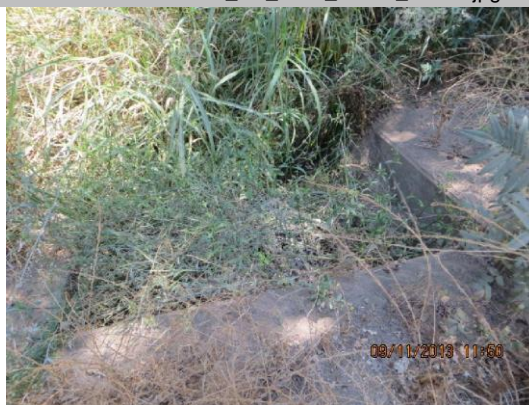
Photo 2 of 3 : UCIP\_SP\_2018\_41354\_34033.jpg

Concrete headwall on LS toe.

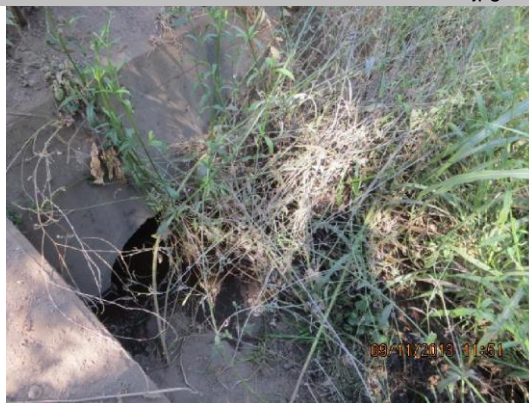
Photo 3 of 3 : UCIP\_SP\_2018\_41354\_34032.jpg

LM Start	1.78	Rating **	M	Issue No.	991 (cont)	
LM End	1.78	Issue Type +	Ma	Location *		
Category	Supplemental			GPS Latitude/Longitude		
				Start	End	
Item	DWR UCIP LMA Responsibility			37.696958 °	37.696958 °	
				-121.177464 °	-121.177464 °	
DWR ID						
Comment Code						
Inspector Comment						
FS_ID:41354 DS_ID:20470 EP_NO: N/A Repair Type: Non-Urgent Crossing Status: Found UCIP Comments: Silt buildup at inlet and outlet. FIELD_STRUCT_DESC: 1 of 2: 24-inch corrugated metal drainage pipe through the levee, 9.5 feet below the crown. Concrete U-shaped headwalls on both ends. Flap gate on the waterside (WS) end. Installed by USACE in 1966. [Additional Reference(s): DWR Levee Log, 2005. USACE San Joaquin O&M Manual 4, June 1968, (HLM 1.80)]. FS Date: 9/11/2013

Concrete headwall at LS toe.

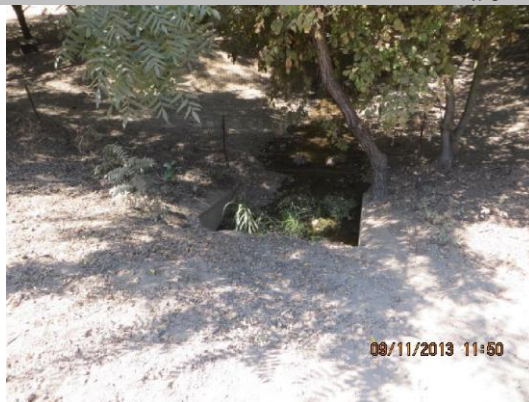
Photo 1 of 3 : UCIP\_SP\_2018\_20092\_34041.jpg

LM Start	1.78	Rating **	M	Issue No.	992
LM End	1.78	Issue Type +	Ma	Location *	
Category	Supplemental			GPS Latitude/Longitude	
				Start	End
Item	DWR UCIP LMA Responsibility			37.696943 °	37.696943 °
				-121.177470 °	-121.177470 °
DWR ID					
Comment Code					
Inspector Comment					
FS_ID:20092 DS_ID:20447 EP_NO: N/A Repair Type: Non-Urgent Crossing Status: Found UCIP Comments: Silt buildup at inlet and outlet. FIELD_STRUCT_DESC: 2 of 2: 24-inch corrugated metal drainage pipe through the levee, 9.5 feet below the crown. Concrete U-shaped headwalls on both ends. Flap gate on the waterside (WS) end. Installed by USACE in 1966. [Additional Reference(s): DWR Levee Log, 2005. USACE San Joaquin O&M Manual 4, June 1968, (HLM 1.80)]. FS Date: 9/11/2013

Concrete U-shaped headwall on WS toe.

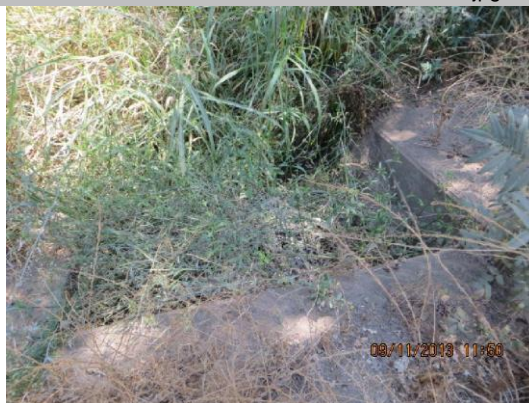
Photo 2 of 3 : UCIP\_SP\_2018\_20092\_34040.jpg

LM Start	1.78	Rating **	M	Issue No.	992 (cont)	
LM End	1.78	Issue Type +	Ma	Location *		
Category	Supplemental			GPS Latitude/Longitude		
				Start	End	
Item	DWR UCIP LMA Responsibility			37.696943 °	37.696943 °	
				-121.177470 °	-121.177470 °	
DWR ID						
Comment Code						
Inspector Comment						
FS_ID:20092 DS_ID:20447 EP_NO: N/A Repair Type: Non-Urgent Crossing Status: Found UCIP Comments: Silt buildup at inlet and outlet. FIELD_STRUCT_DESC: 2 of 2: 24-inch corrugated metal drainage pipe through the levee, 9.5 feet below the crown. Concrete U-shaped headwalls on both ends. Flap gate on the waterside (WS) end. Installed by USACE in 1966. [Additional Reference(s): DWR Levee Log, 2005. USACE San Joaquin O&M Manual 4, June 1968, (HLM 1.80)]. FS Date: 9/11/2013

Concrete U-shaped headwall on LS toe.

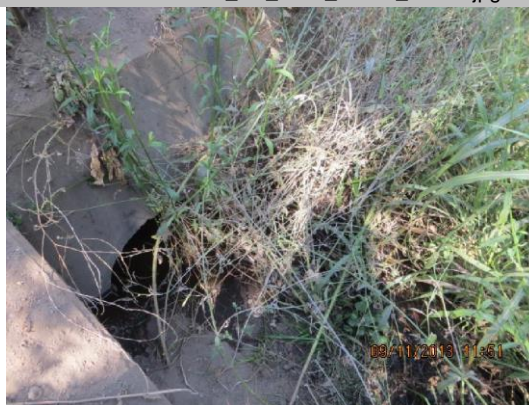
Photo 3 of 3 : UCIP\_SP\_2018\_20092\_34039.jpg

Concrete U-shaped headwall on LS toe.

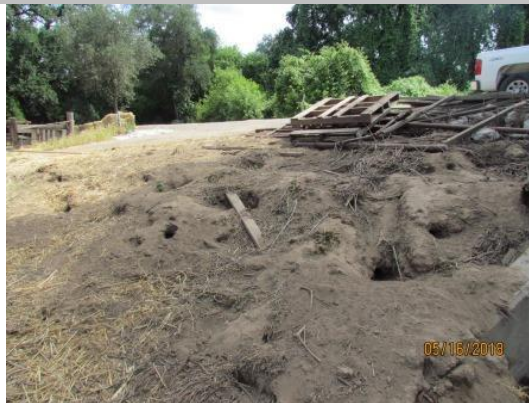
Photo 1 of 1 : SP\_2018\_RD2031\_307\_49\_20180517\_00110.jpg

View of the waterside where several squirrel holes are and active rodent activity.

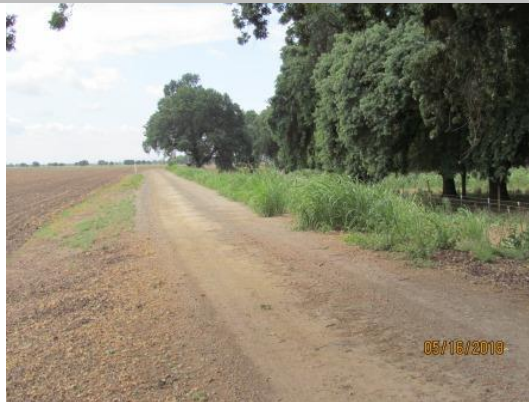
Photo 1 of 1 : SP\_2018\_RD2031\_307\_52\_20180517\_00111.jpg

View looking downstream waterside of a section where the annual vegetation needs to be maintained, Spring 2018.

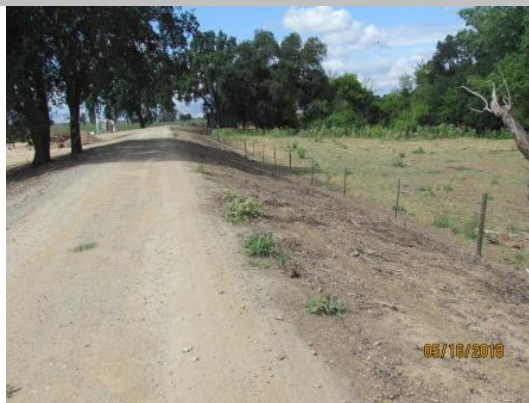
Photo 1 of 1 : SP\_2018\_RD2031\_307\_54\_20180517\_00112.jpg

View looking downstream waterside of the well maintained annual vegetation, Spring 2018.

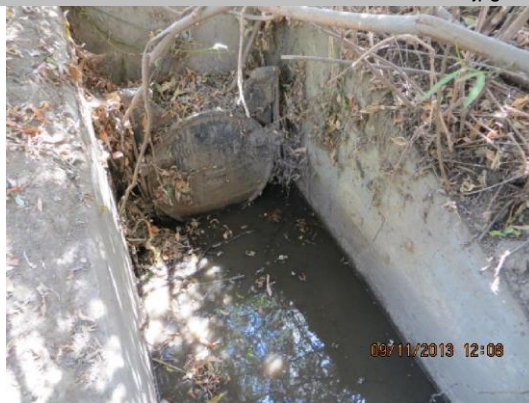
Photo 1 of 3 : UCIP\_SP\_2018\_20110\_34078.jpg

LM Start	2.39	Rating **	A/W	Issue No.	994	
LM End	2.39	Issue Type +	Ma	Location *		
Category	Supplemental			GPS Latitude/Longitude		
				Start		End
Item	DWR UCIP LMA Responsibility			37.688676 °	37.688676 °	
				-121.179622 °	-121.179622 °	
DWR ID						
Comment Code						
Inspector Comment						
FS_ID:20110 DS_ID:20449 EP_NO: N/A Repair Type: No Action Needed Crossing Status: Found UCIP Comments: FIELD_STRUCT_DESC: 24-inch corrugated metal drainage pipe through the levee, 3 feet below the crown. Concrete U-shaped headwall on the waterside (WS) end. Flap gate on the WS end. 5-foot by 5-foot concrete riser with pump on the LS toe. Likely that concrete riser is inlet for drainage pipe. [Additional Reference(s): DWR Levee Log, 2005. USACE San Joaquin O&M Manual 4, June 1968, (HLM 2.41)]. FS Date: 9/11/2013

Flapgate and concrete headwall on WS toe.

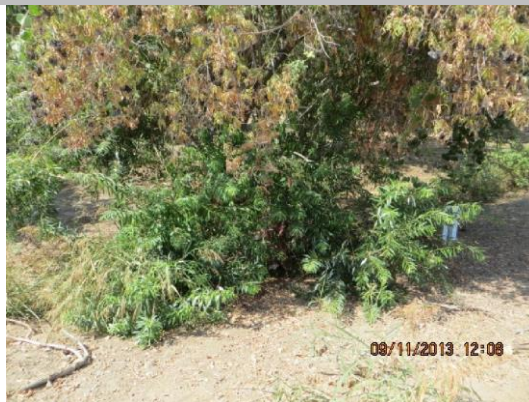
Photo 2 of 3 : UCIP\_SP\_2018\_20110\_34077.jpg

Vegetation covers outlet of pipe on WS slope.

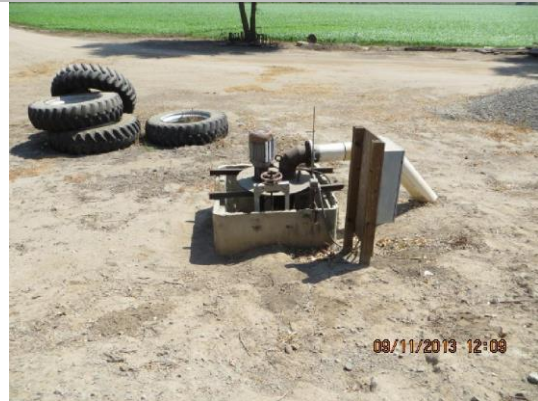
Photo 3 of 3 : UCIP\_SP\_2018\_20110\_34076.jpg

LM Start	2.39	Rating **	A/W	Issue No.	994 (cont)	
LM End	2.39	Issue Type +	Ma	Location *		
Category	Supplemental			GPS Latitude/Longitude		
				Start	End	
Item	DWR UCIP LMA Responsibility			37.688676 °	37.688676 °	
				-121.179622 °	-121.179622 °	
DWR ID						
Comment Code						
Inspector Comment						
FS_ID:20110 DS_ID:20449 EP_NO: N/A Repair Type: No Action Needed Crossing Status: Found UCIP Comments: FIELD_STRUCT_DESC: 24-inch corrugated metal drainage pipe through the levee, 3 feet below the crown. Concrete U-shaped headwall on the waterside (WS) end. Flap gate on the WS end. 5-foot by 5-foot concrete riser with pump on the LS toe. Likely that concrete riser is inlet for drainage pipe. [Additional Reference(s): DWR Levee Log, 2005. USACE San Joaquin O&M Manual 4, June 1968, (HLM 2.41)]. FS Date: 9/11/2013

5'X5' concrete riser with pump on LS toe.

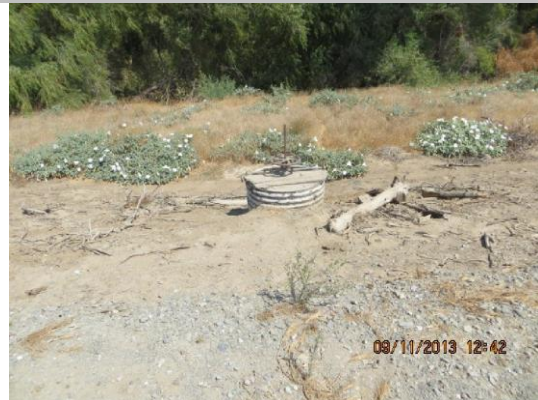
Photo 1 of 3 : UCIP\_SP\_2018\_20449\_34506.jpg

LM Start	3.08	Rating **	M	Issue No.	996
LM End	3.08	Issue Type +	Ma	Location *	
Category	Supplemental			GPS Latitude/Longitude	
				Start	End
Item	DWR UCIP LMA Responsibility			37.688297 °	37.688297 °
				-121.190865 °	-121.190865 °
DWR ID					
Comment Code					
Inspector Comment					
FS_ID:20449					
DS_ID:20451					
EP_NO: N/A					
Repair Type: Non-Urgent					
Crossing Status: Found					
UCIP Comments: Pipe appears to be abandoned and if so should be done so properly.					
FIELD_STRUCT_DESC: *ABANDONED* 24-inch corrugated metal drainage pipe through the levee, 14 feet below the crown. Slide gate in a 36-inch corrugated metal pipe (CMP) riser on the waterside (WS) slope. [Additional Reference(s): DWR Levee Log, 2005. USACE San Joaquin O&M Manual 4, June 1968, (HLM 3.11)].					
FS Date: 9/11/2013

Slide gate in CMP riser on WS slope.

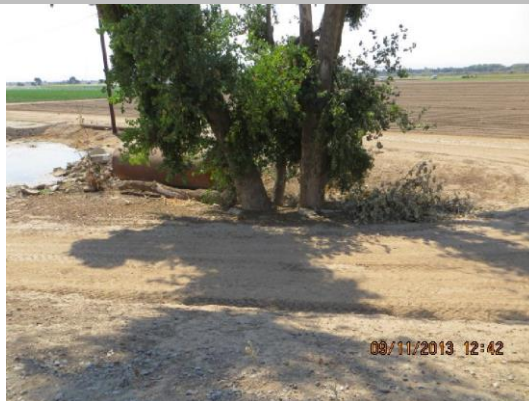
Photo 2 of 3 : UCIP\_SP\_2018\_20449\_34505.jpg

LM Start	3.08	Rating **	M	Issue No.	996 (cont)	
LM End	3.08	Issue Type +	Ma	Location *		
Category	Supplemental			GPS Latitude/Longitude		
				Start		End
Item	DWR UCIP LMA Responsibility			37.688297 °	37.688297 °	
				-121.190865 °	-121.190865 °	
DWR ID						
Comment Code						
Inspector Comment						
FS_ID:20449 DS_ID:20451 EP_NO: N/A Repair Type: Non-Urgent Crossing Status: Found UCIP Comments: Pipe appears to be abandoned and if so should be done so properly. FIELD_STRUCT_DESC: *ABANDONED* 24-inch corrugated metal drainage pipe through the levee, 14 feet below the crown. Slide gate in a 36-inch corrugated metal pipe (CMP) riser on the waterside (WS) slope. [Additional Reference(s): DWR Levee Log, 2005. USACE San Joaquin O&M Manual 4, June 1968, (HLM 3.11)]. FS Date: 9/11/2013

Pipe not visible on LS toe.

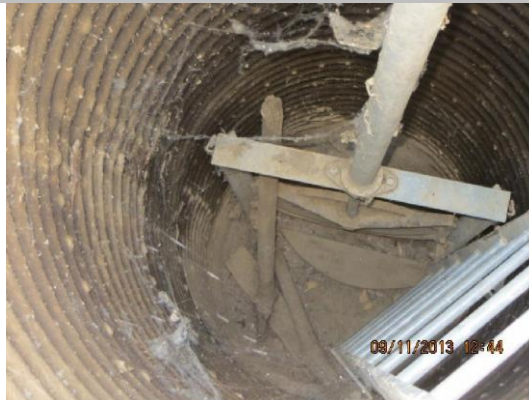
Photo 3 of 3 : UCIP\_SP\_2018\_20449\_34504.jpg

Slide gate in CMP riser on WS slope.

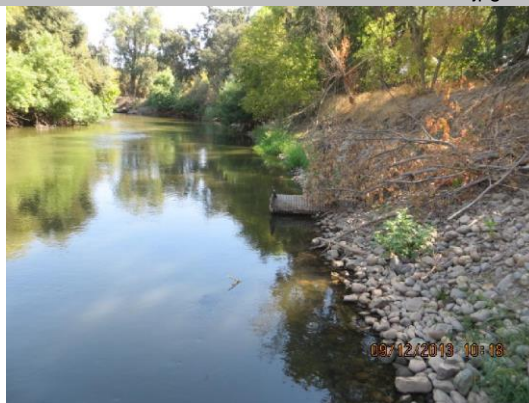
Photo 1 of 2 : UCIP\_SP\_2018\_23064\_39200.jpg

LM Start	3.66	Rating **	M	Issue No.	997
LM End	3.66	Issue Type +	Ma	Location *	
Category	Supplemental			GPS Latitude/Longitude	
				Start	End
Item	DWR UCIP LMA Responsibility			37.689900 °	37.689900 °
				-121.198319 °	-121.198319 °
DWR ID					
Comment Code					
Inspector Comment					
FS_ID:23064					
DS_ID:20478					
EP_NO: N/A					
Repair Type: Non-Urgent					
Crossing Status: Found					
UCIP Comments: Good candidate for video inspection.					
FIELD_STRUCT_DESC: 24-inch corrugated metal drainage pipe through the levee, 5.5 feet below the crown. Flap gate visible at the waterside (WS) toe. [Additional Reference(s): USACE San Joaquin O&M Manual 4, June 1968, (HLM 3.7), listed as a 20-inch pipe, 3.9 feet below the crown].					
FS Date: 9/12/2013

CMP pipe and flapgate visible at WS toe.

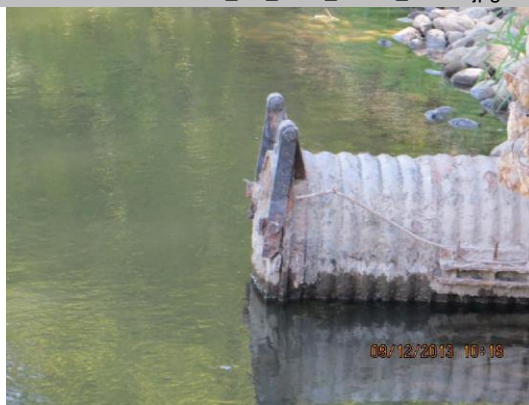
Photo 2 of 2 : UCIP\_SP\_2018\_23064\_39199.jpg

CMP pipe and flapgate visible at WS toe.

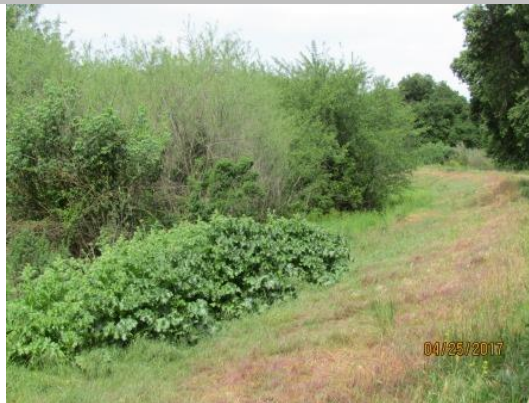
Photo 1 of 4 : SP\_2018\_RD2031\_307\_33\_20180515\_00014.jpg

View of the vegetation at the levee toe and slope.

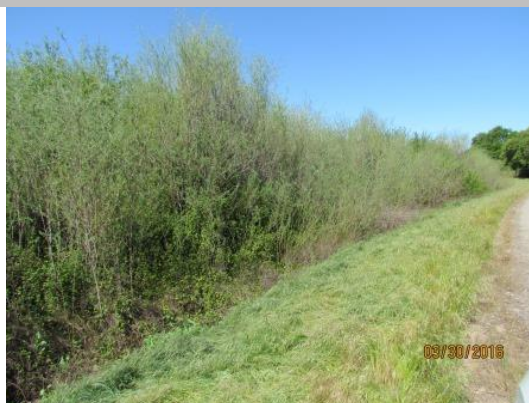
Photo 2 of 4 : SP\_2018\_RD2031\_307\_33\_20180515\_00015.jpg

Typical view of the tall vegetation on the landside levee slope and toe in this area.

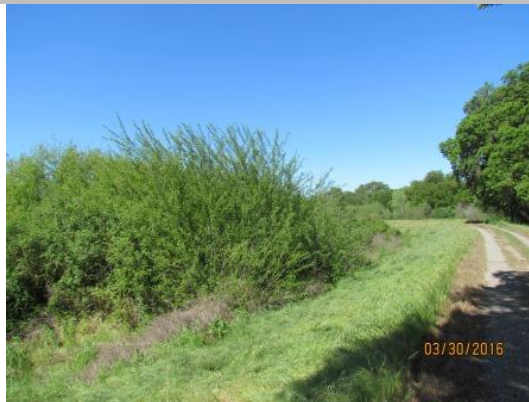
Photo 3 of 4 : SP\_2018\_RD2031\_307\_33\_20180515\_00016.jpg

View of the tall vegetation on the landside levee slope and toe.

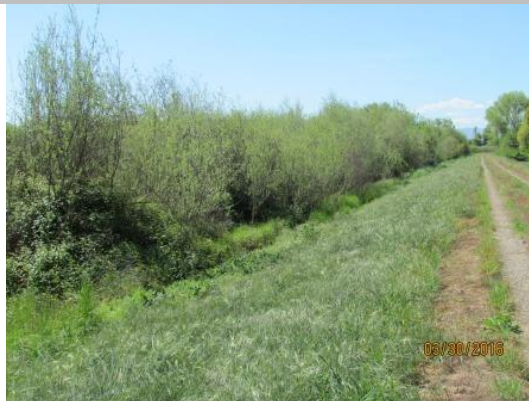
Photo 4 of 4 : SP\_2018\_RD2031\_307\_33\_20180515\_00017.jpg

Another view of the tall vegetation on the landside levee slope and toe.

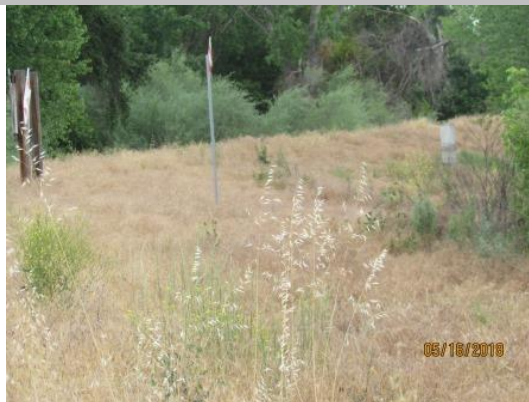
Photo 1 of 1 : SP\_2018\_RD2031\_307\_56\_20180517\_00113.jpg

View looking upstream of the levee where the annual vegetation through the wild life persevere need to be maintained on the crown, landside, and waterside, Spring 2018.

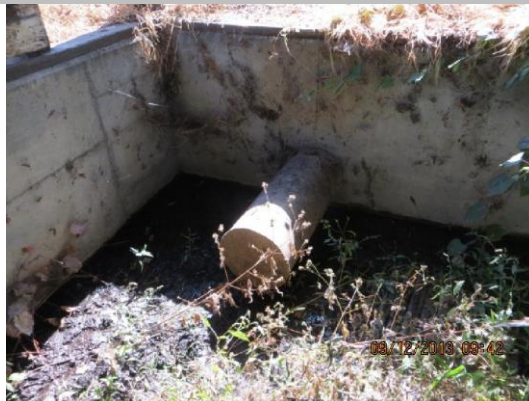
Photo 2 of 3 : UCIP\_SP\_2018\_20683\_34781.jpg

LM Start	4.41	Rating **	A/W	Issue No.	1002 (cont)
LM End	4.41	Issue Type +	Ma	Location *	
Category	Supplemental			GPS Latitude/Longitude	
				Start	End
Item	DWR UCIP LMA Responsibility			37.686290 °	37.686290 °
				-121.208000 °	-121.208000 °
DWR ID					
Comment Code					
Inspector Comment					
FS_ID:20683 DS_ID:20458 EP_NO: N/A Repair Type: No Action Needed Crossing Status: Found UCIP Comments: FIELD_STRUCT_DESC: *ABANDONED* 1 of 2: 14-inch concrete encased steel drainage pipe through the levee, 7.5 feet below the crown. Plate welded on the waterside (WS) end. 6-foot by 12-foot concrete distribution box on the landside (LS) toe. [Additional Reference(s): DWR Levee Log, 2005. USACE San Joaquin O&M Manual 4, June 1968, (HLM 4.46)]. FS Date: 9/12/2013

Welded steel plate over WS end of pipe.

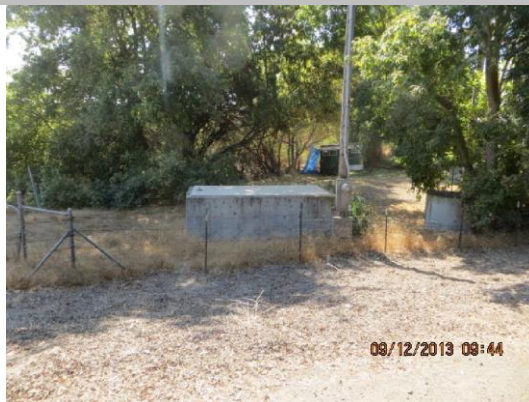
Photo 3 of 3 : UCIP\_SP\_2018\_20683\_34780.jpg

Concrete distribution box on LS toe.

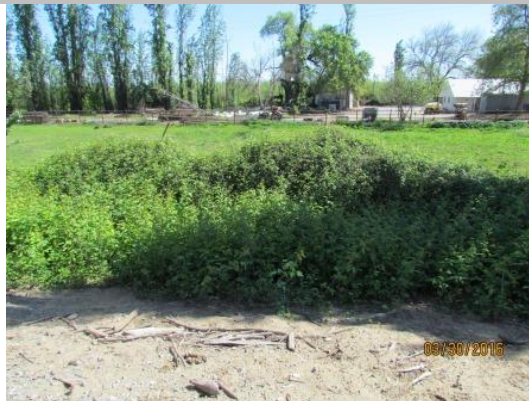
Photo 1 of 1 : SP\_2018\_RD2031\_307\_43\_20180515\_00024.jpg

View of the tall vegetation on the landside levee slope and toe.

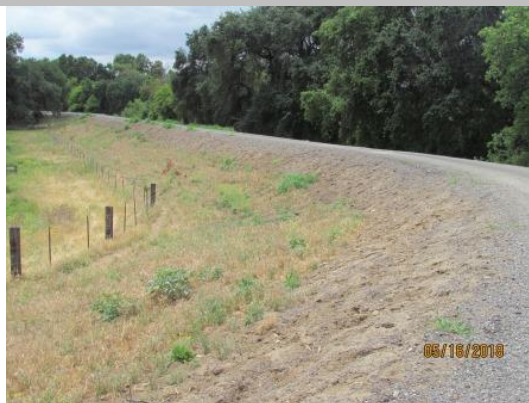
Photo 1 of 1 : SP\_2018\_RD2031\_308\_15\_20180517\_00049.jpg

View looking downstream landside of the well maintained annual vegetation.

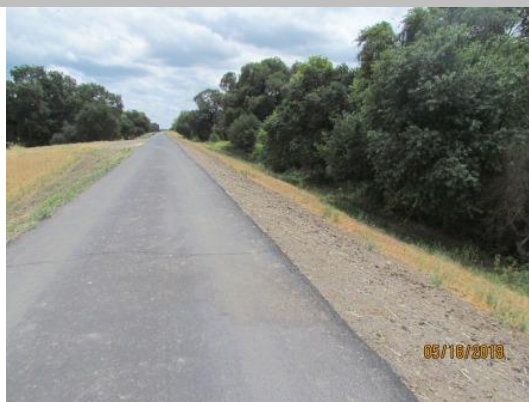
Photo 1 of 1 : SP\_2018\_RD2031\_308\_16\_20180517\_00048.jpg

View looking downstream waterside of the well maintained annual vegetation.

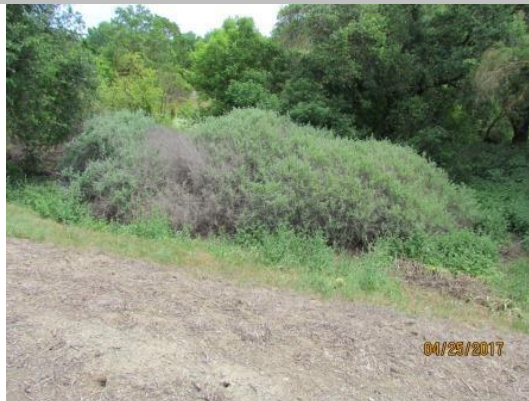
Photo 1 of 1 : SP\_2018\_RD2031\_308\_20\_20180515\_00007.jpg

View of the dense shrubs at the levee toe.

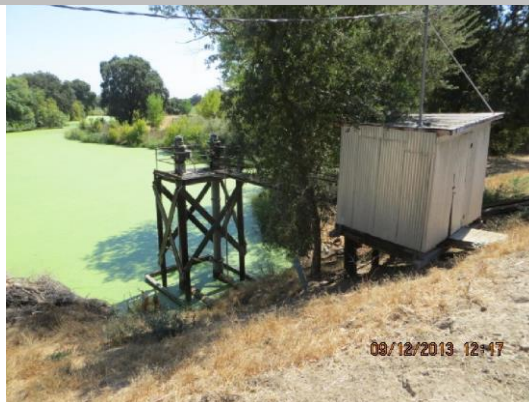
Photo 1 of 3 : UCIP\_SP\_2018\_20703\_34822.jpg

LM Start	0.22	Rating **	A/W	Issue No.	967
LM End	0.22	Issue Type +	Ma	Location *	
Category	Supplemental			GPS Latitude/Longitude	
				Start	End
Item	DWR UCIP LMA Responsibility			37.658888 °	37.658888 °
				-121.234274 °	-121.234274 °
DWR ID					
Comment Code					
Inspector Comment					
FS_ID:20703					
DS_ID:20482					
EP_NO: N/A					
Repair Type: No Action Needed					
Crossing Status: Found					
UCIP Comments:					
FIELD_STRUCT_DESC: 1 of 2: 24-inch steel drainage pipe through the levee, 3.6 feet below the crown. Concrete U-shaped headwall on the waterside (WS) end. Flap gate on the WS end. Pump on pile structure on the landside (LS). [Additional Reference(s): DWR Levee Log, 2005. USACE San Joaquin O&M Manual 4, June 1968, (HLM 0.24)].					
FS Date: 9/12/2013

Pump on platform at LS toe.

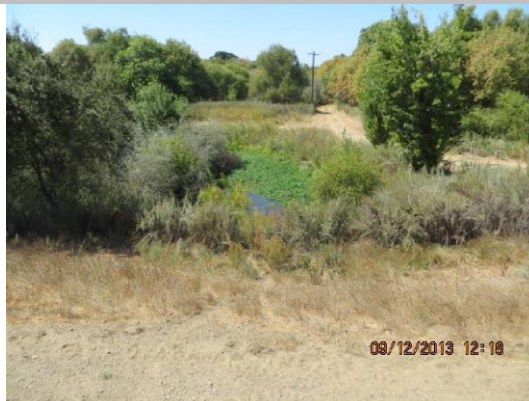
Photo 2 of 3 : UCIP\_SP\_2018\_20703\_34821.jpg

Pond at outlet on WS toe.

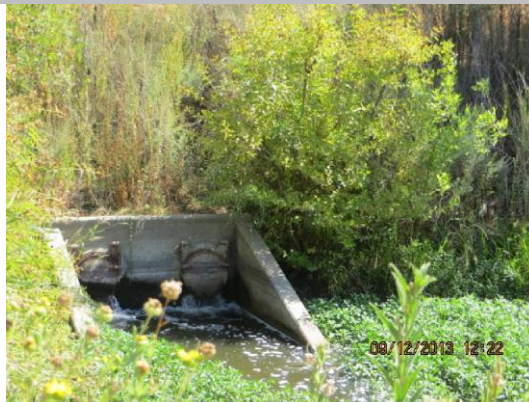
Photo 3 of 3 : UCIP\_SP\_2018\_20703\_34820.jpg

Concrete U-shaped headwall with flapgate on WS toe.

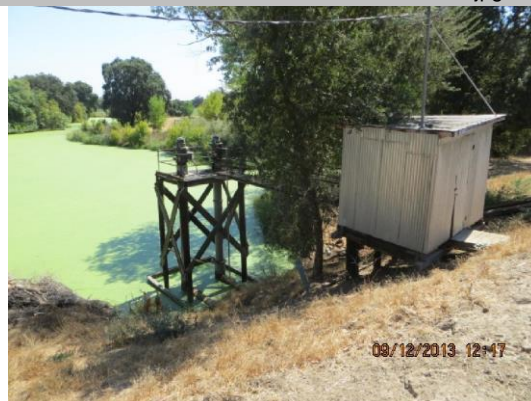
Photo 1 of 3 : UCIP\_SP\_2018\_20704\_34826.jpg

Pump on pier on LS toe with shed at pump walkway.

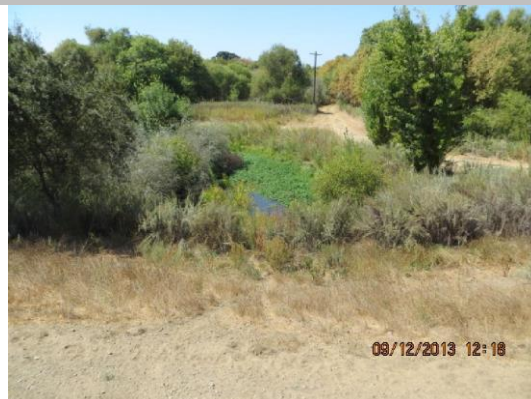
Photo 2 of 3 : UCIP\_SP\_2018\_20704\_34825.jpg

Pond at outlet on WS toe.

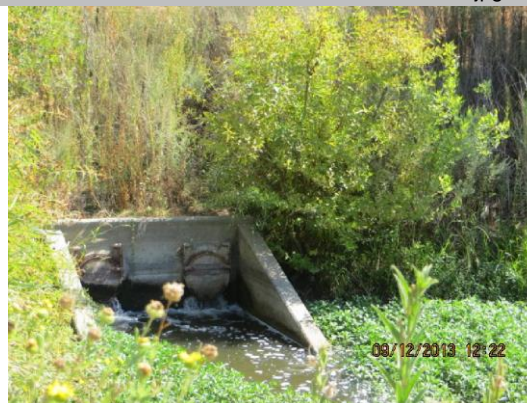
Photo 3 of 3 : UCIP\_SP\_2018\_20704\_34824.jpg

Flap gate at Concrete outlet on WS toe.

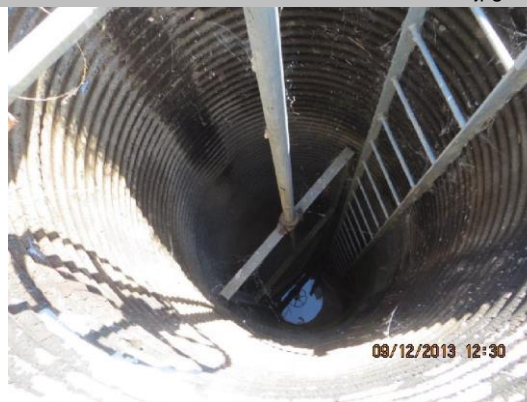
Photo 1 of 3 : UCIP\_SP\_2018\_52626\_34834.jpg

Slide gate in CMP riser on WS slope.

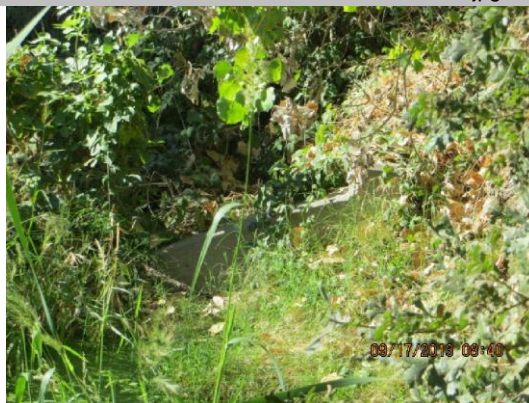
Photo 2 of 3 : UCIP\_SP\_2018\_52626\_34833.jpg

Concrete headwall on LS toe at edge of pond.

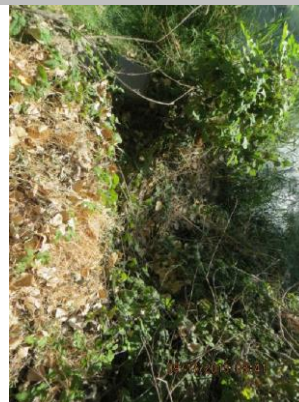
Photo 3 of 3 : UCIP\_SP\_2018\_52626\_34832.jpg

Concrete headwall on LS toe at edge of pond.

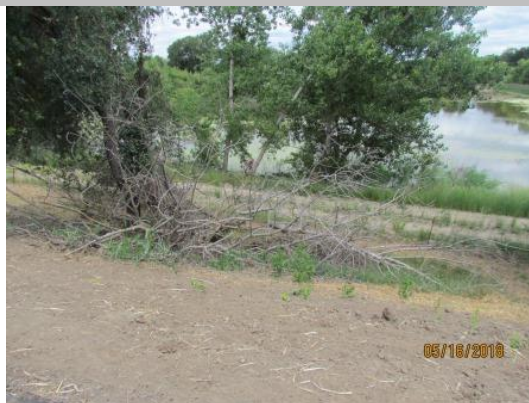
Photo 1 of 1 : SP\_2018\_RD2031\_308\_18\_20180517\_00051.jpg

View of a fallen tree on the landside levee slope that needs to be removed, Spring 2018.

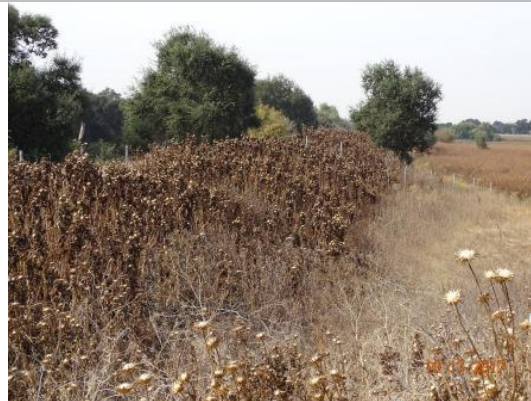
Photo 1 of 1 : SP\_2018\_RD2031\_308\_30\_20180515\_00014.jpg

View of the dense vegetation on the landside levee slope.

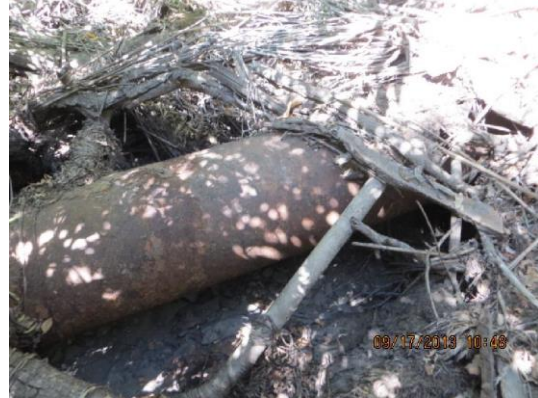
Photo 1 of 3 : UCIP\_SP\_2018\_20713\_34838.jpg

Pipe visible on LS toe.

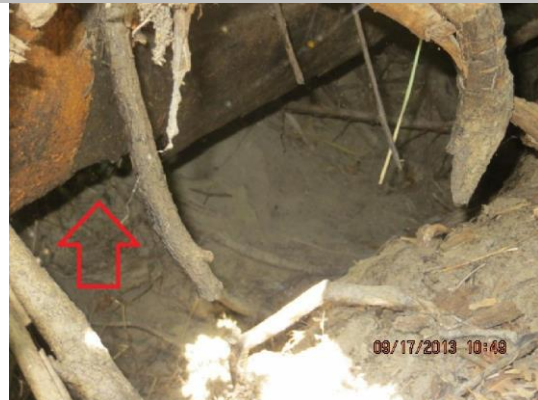
Photo 2 of 3 : UCIP\_SP\_2018\_20713\_34837.jpg

Flow line of pipe completely rusted through at LS toe.

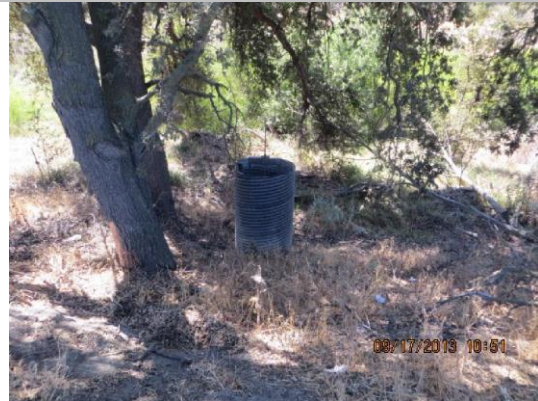
Photo 3 of 3 : UCIP\_SP\_2018\_20713\_34836.jpg

Slide gate in 48-inch CMP riser on WS slope.

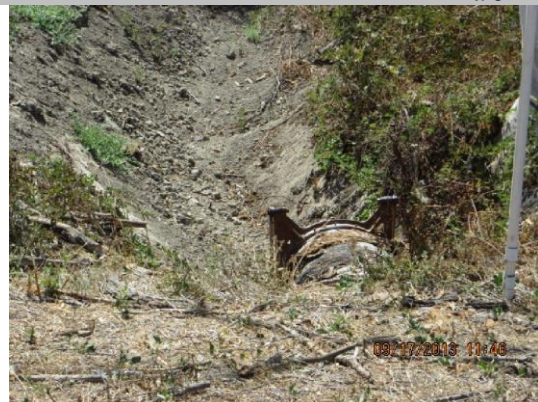
Photo 1 of 3 : UCIP\_SP\_2018\_20723\_34882.jpg

Flap gate on CMP pipe at WS toe.

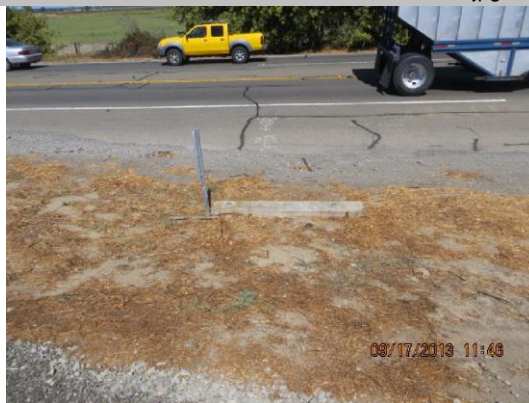
Photo 2 of 3 : UCIP\_SP\_2018\_20723\_34881.jpg

Concrete headwall on LS toe.

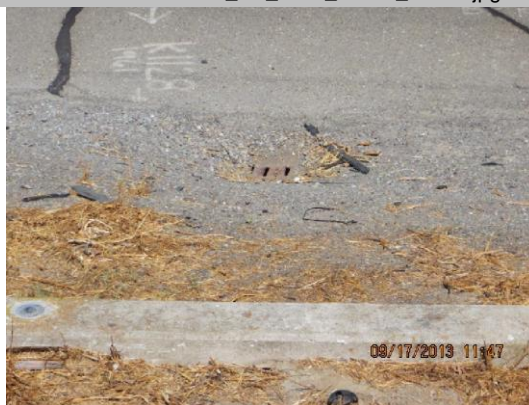
Photo 3 of 3 : UCIP\_SP\_2018\_20723\_34880.jpg

Drop inlet on LS toe.

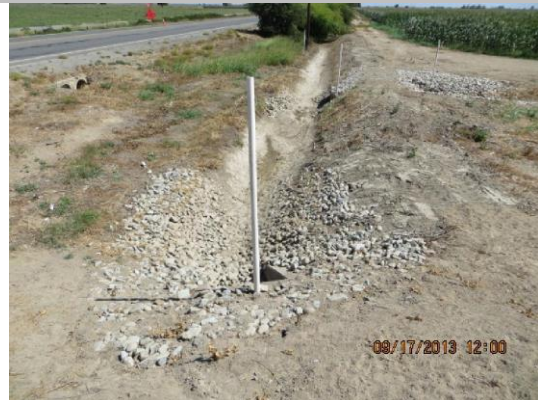
Photo 1 of 3 : UCIP\_SP\_2018\_51374\_34886.jpg

Concrete headwall on LS toe.

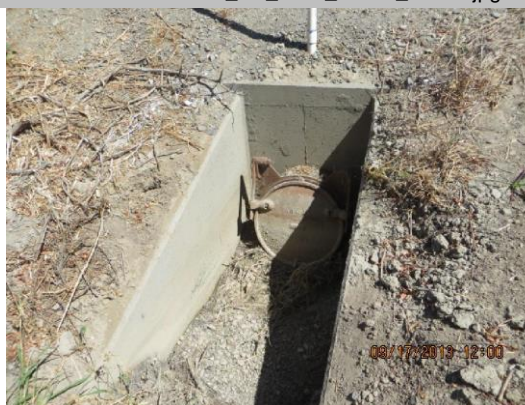
Photo 3 of 3 : UCIP\_SP\_2018\_51374\_34884.jpg

Flapgate on WS toe.

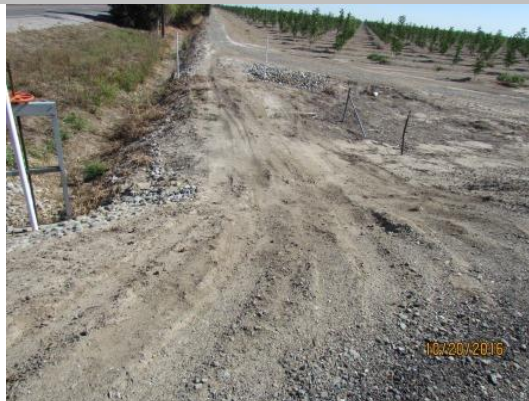
Photo 1 of 1 : SP\_2018\_RD2031\_308\_17\_20180515\_00006.jpg

View of the tire tracks on the levee slope.

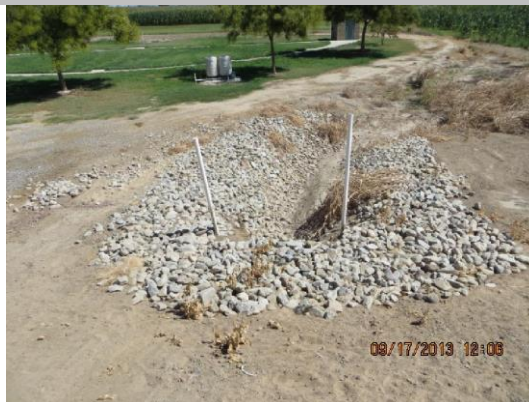
Photo 1 of 3 : UCIP\_SP\_2018\_20728\_34895.jpg

Concrete headwall at ditch on LS toe.

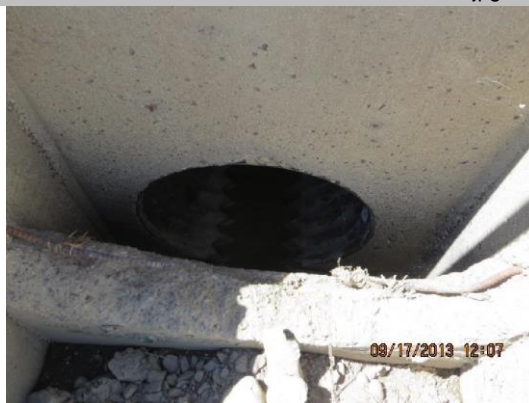
Photo 2 of 3 : UCIP\_SP\_2018\_20728\_34894.jpg

Concrete headwall on LS toe.

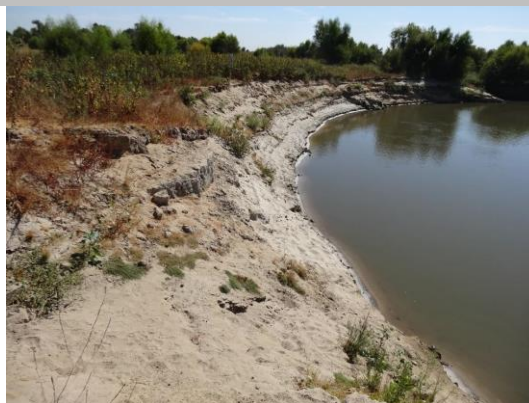
Photo 1 of 4 : SP\_2018\_RD2031\_308\_1\_20180515\_00001.jpg

Looking upstream of the erosion site.

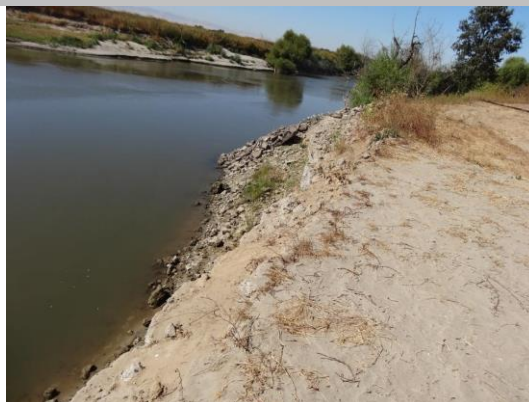
Photo 2 of 4 : SP\_2018\_RD2031\_308\_1\_20180515\_00002.jpg

Looking downstream of the erosion site.

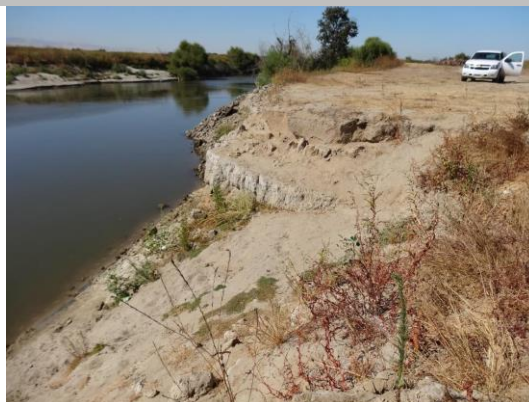
Photo 4 of 4 : SP\_2018\_RD2031\_308\_1\_20180515\_00004.jpg

Close view of the erosion.
